Assessment of Dam Safety

Coal Combustion Surface Impoundments (Task 3)

Final Report

Duke Energy
Buck Steam Station
Spencer, North Carolina

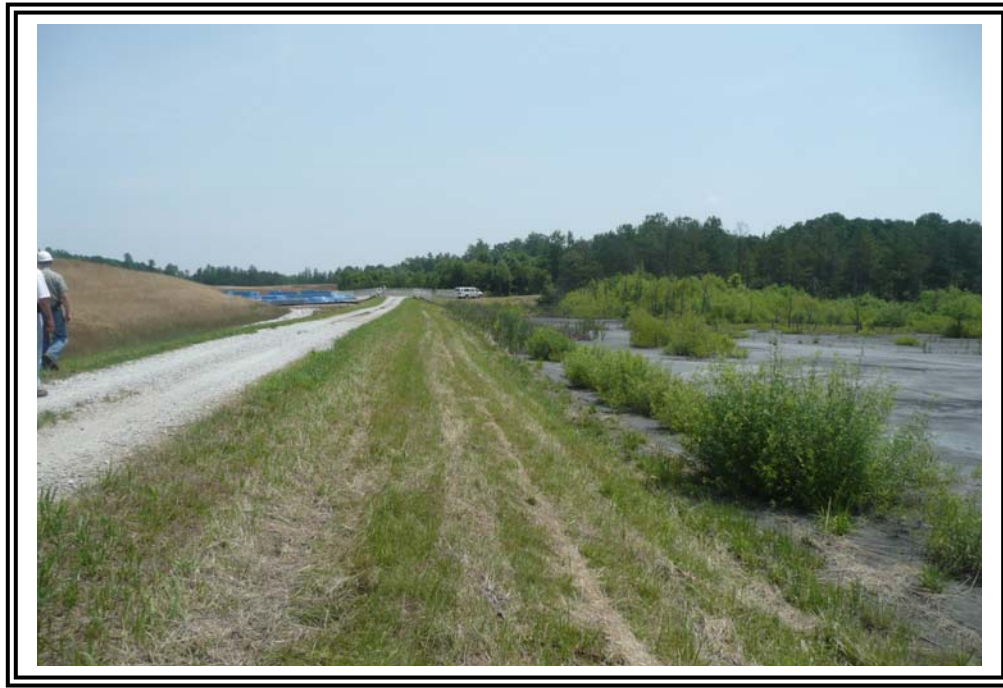
3

New Dike crest and upstream slope looking northeast towards North Abutment (note van is on abutment).

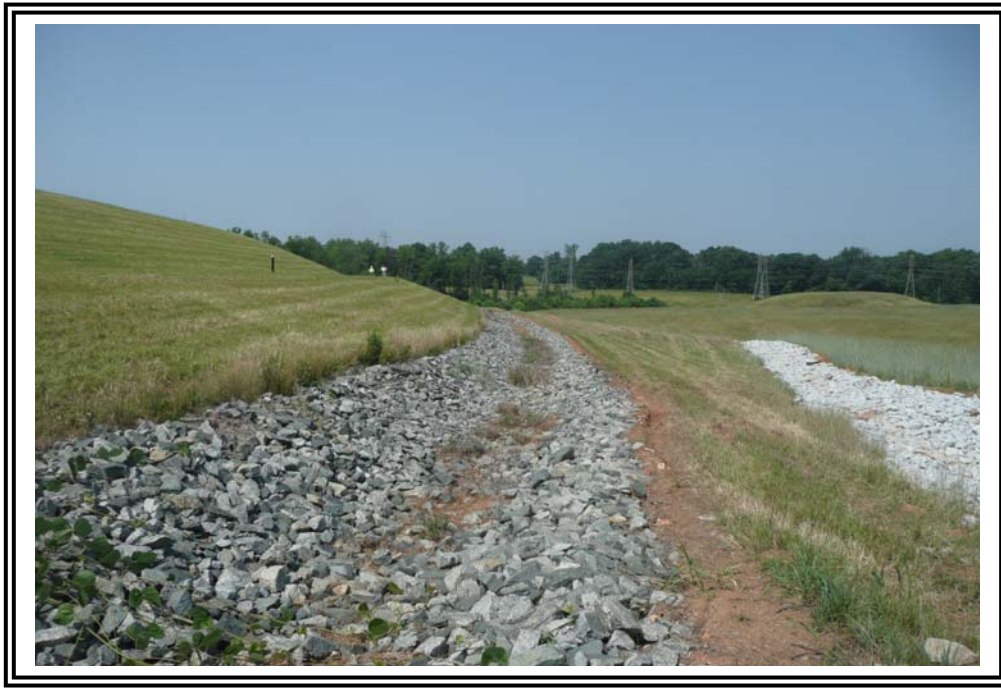
9

Downstream slope and toe drainage swale along northern portion of the New Dike looking southwest.

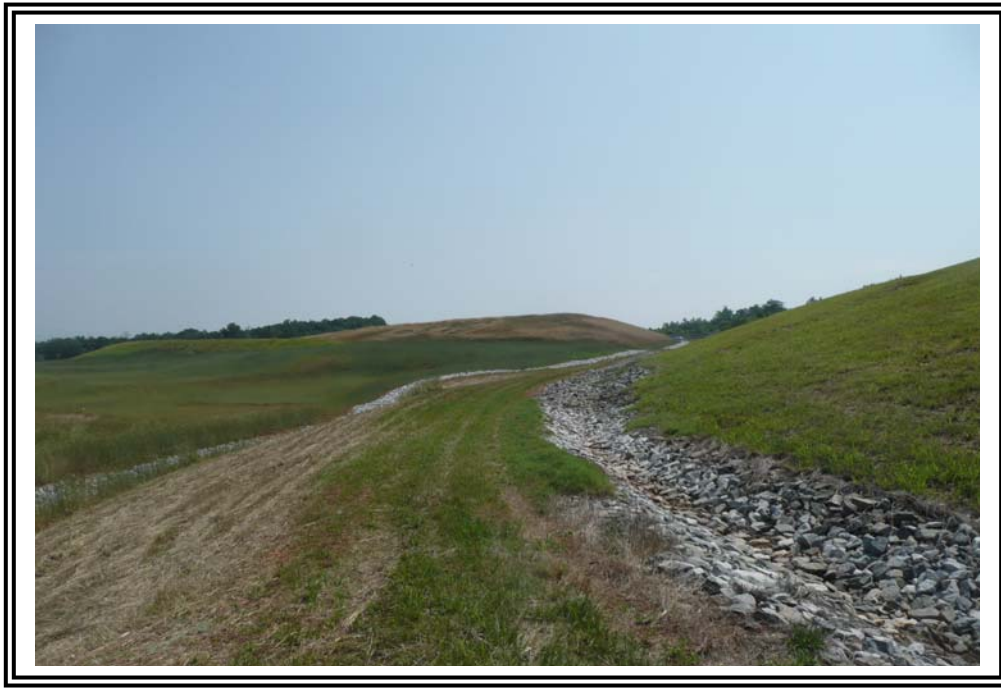
11

Toe of New Dike looking northeast. Toe drainage swale is in right of photo, slope down to the left is natural ground cut to new combined cycle plant site.

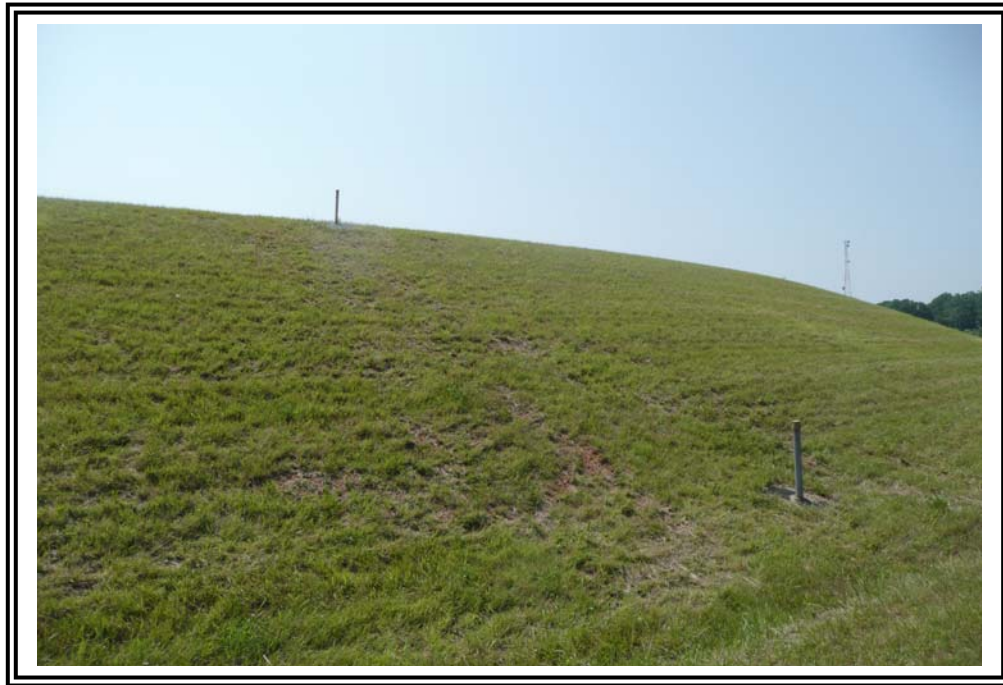
13

Downstream Slope of New Dike looking south. Note sparse grass coverage in some areas.

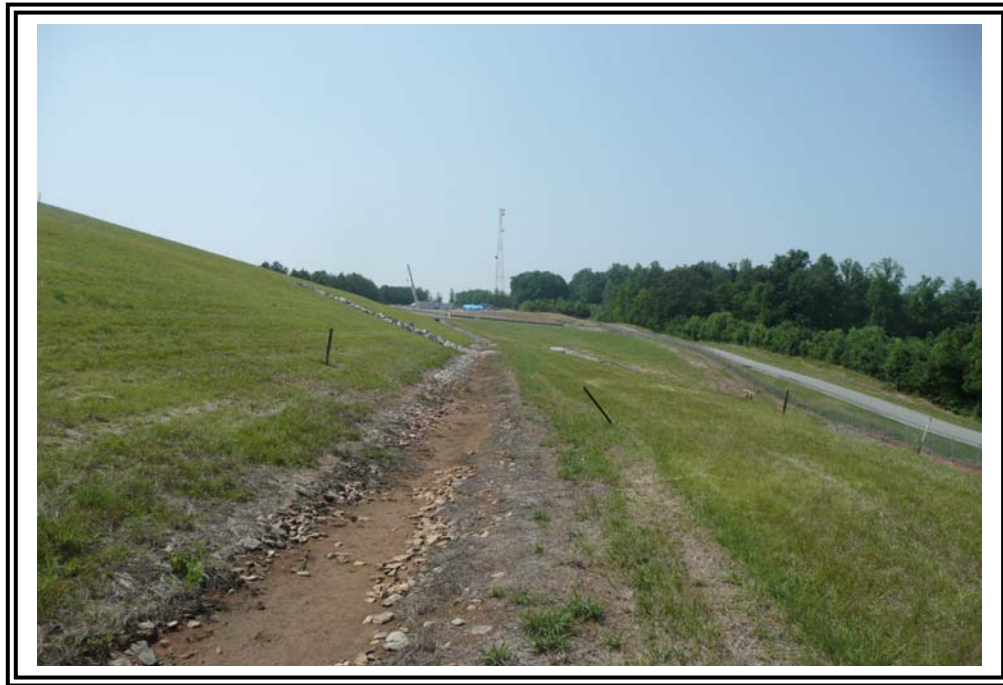
15

Lower Bench of New Dike looking south. Note silt deposited in drainage swale.

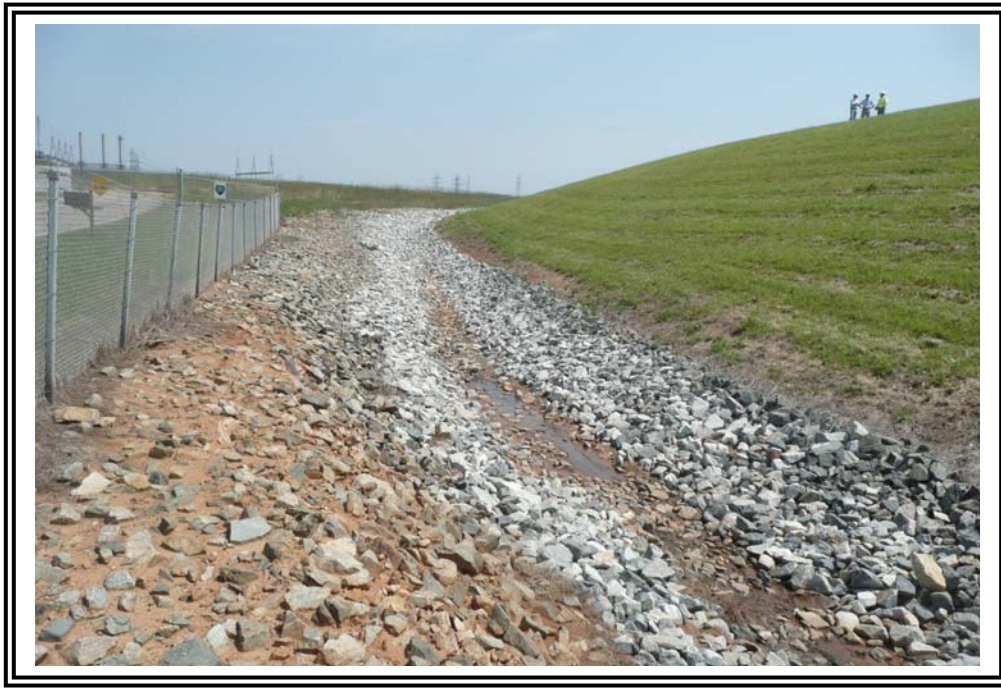
17

Toe swale of New Dike looking north. Area of toe drain seepage. Area starts about 100 feet north of discharge culvert under Dukeville Road.

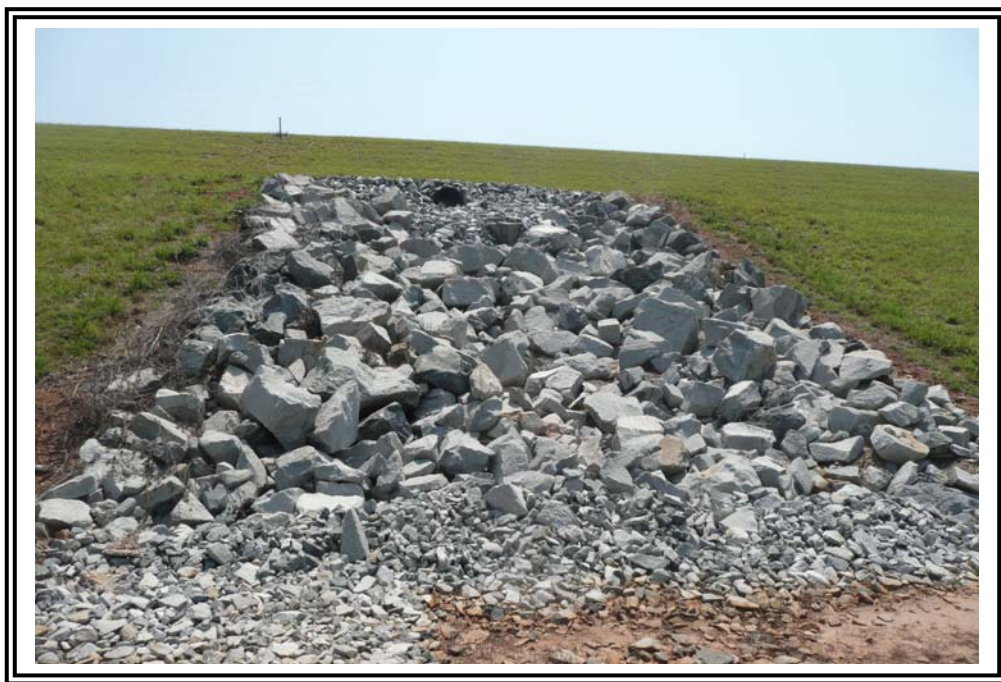
20

Repair area where surface runoff was causing sloughing from Upper Bench to Lower Bench. Repair was completed between 1993 and 1998 based on publically available aerial photos.

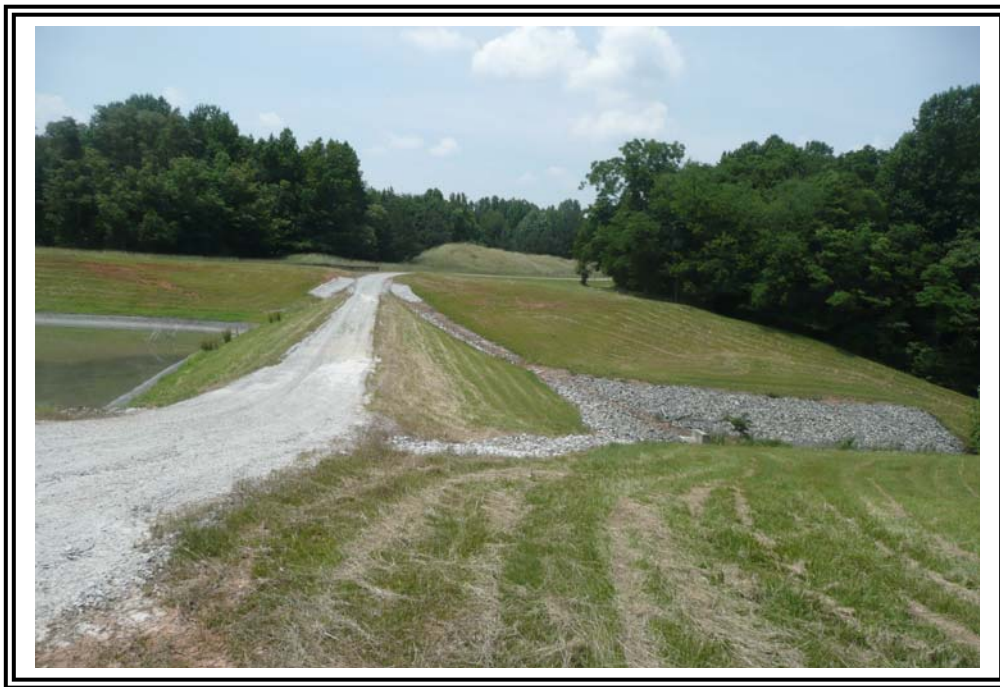
The Basin 1 to Basin 2 Outlet Dam is about 260 feet long. The crest is at El. 710 per design drawings; the same as the new dike. Photos 24 and 25 show this structure. No evidence of prior releases, failures or patchwork on was observed at the time of the site visit. Failure of this structure would not release impounded fluid or materials outside of the basin system although this is discussed further in Section 3.4.

Outlet dam from Basin 1 to Basin 2 looking north. This dam is in a cut channel created to drain Basin 1 into Basin2 through a high point in the natural topography.

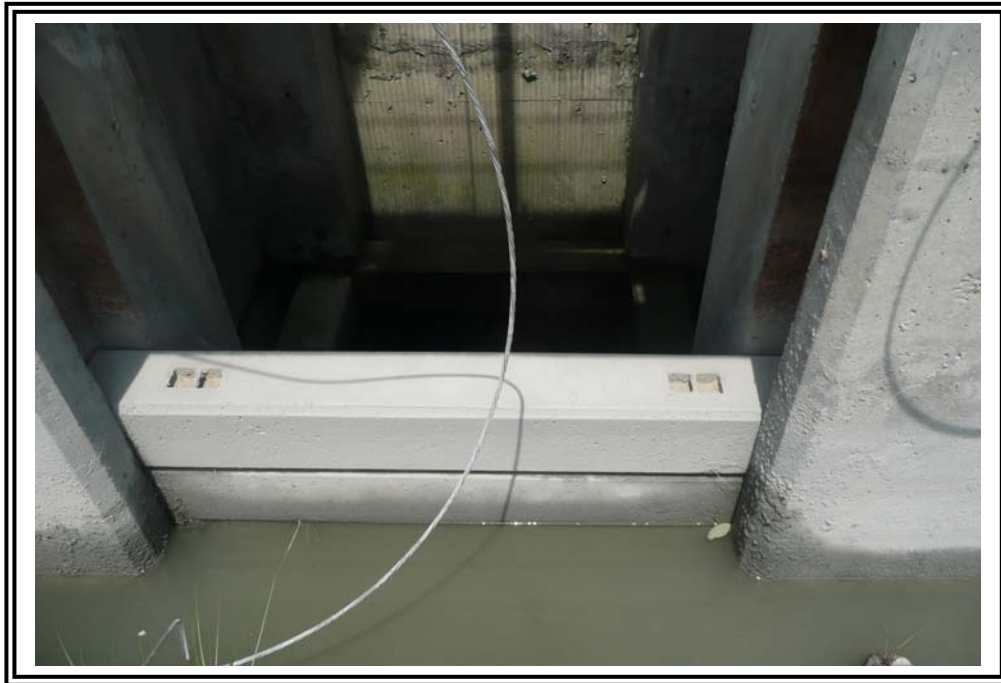
26

Stoplogs in Basin 1 Outlet Tower. During these observations the Buck Plant was not generating power, therefore they were not sluicing CCW into Basin 1. Leakage between the stoplogs had resulted in a lowering of the Basin 1 water level below the normal decant elevation.

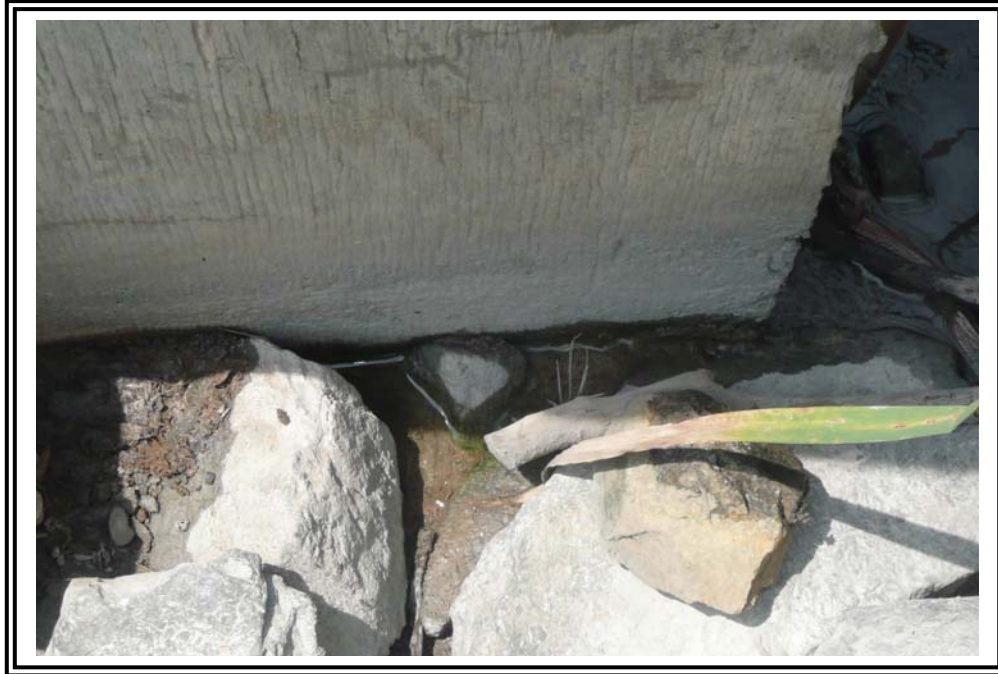
Photos 26 and 27 show the downstream end of the outlet pipe, and the discharge channel between the outlet pipe and Basin 2. Seepage was noted adjacent to the downstream end of the outlet pipe headwall. This seepage flow appeared clear at the time of the site visit.

Seepage noted adjacent to downstream end of outlet pipe headwall.

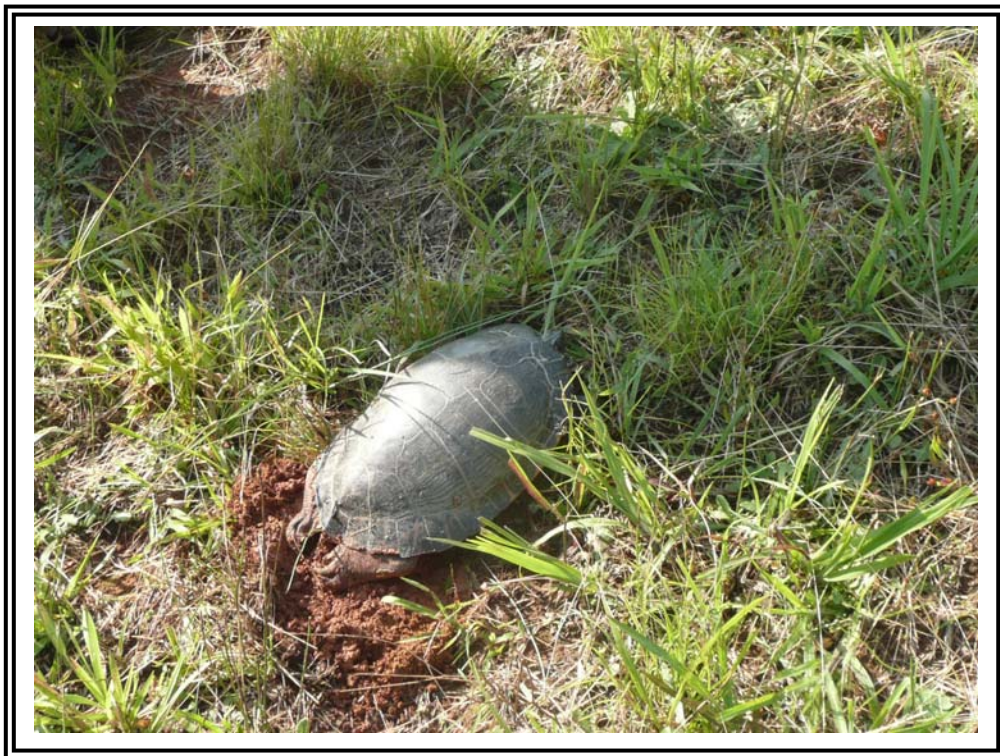
43

The downstream slope of the main dike is reasonably uniform as shown in Photos 41, 44, 48, 50 and 51. Areas of sparse grass coverage were noted as shown in Photos 42, 45, 47 and 50. Areas of animal disturbance were noted in fire ant mounds and by digging turtles (Photo 43).

Close up of animal disturbance on downstream slope of Main Dike.

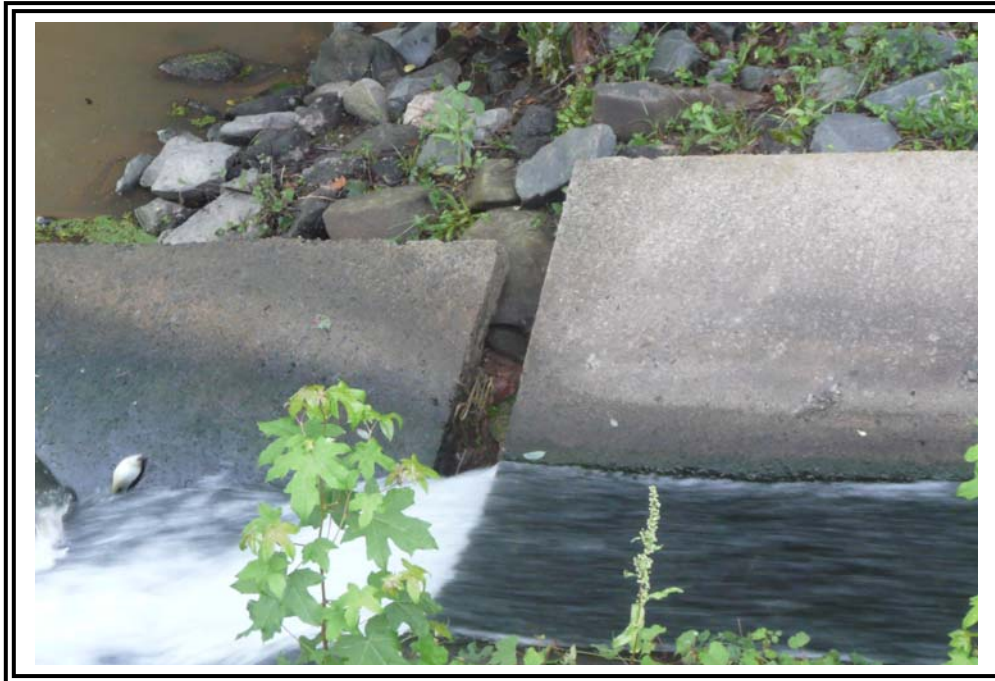
56

Last section of concrete channel has separated. Noted in previous inspection reports.

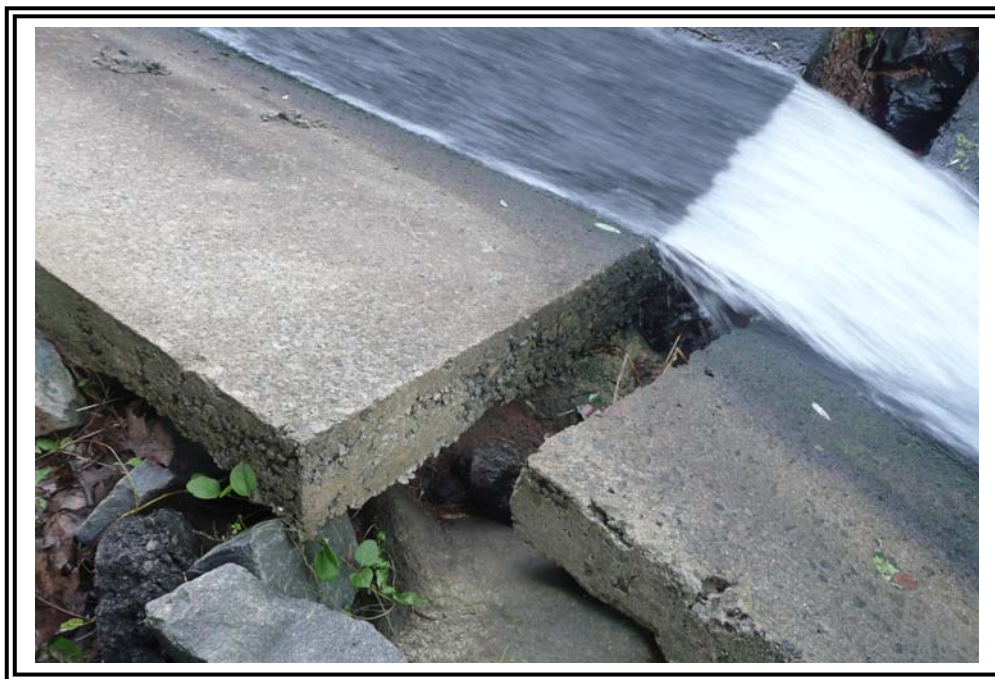
57

Slight undermining of concrete discharge channel at river end.

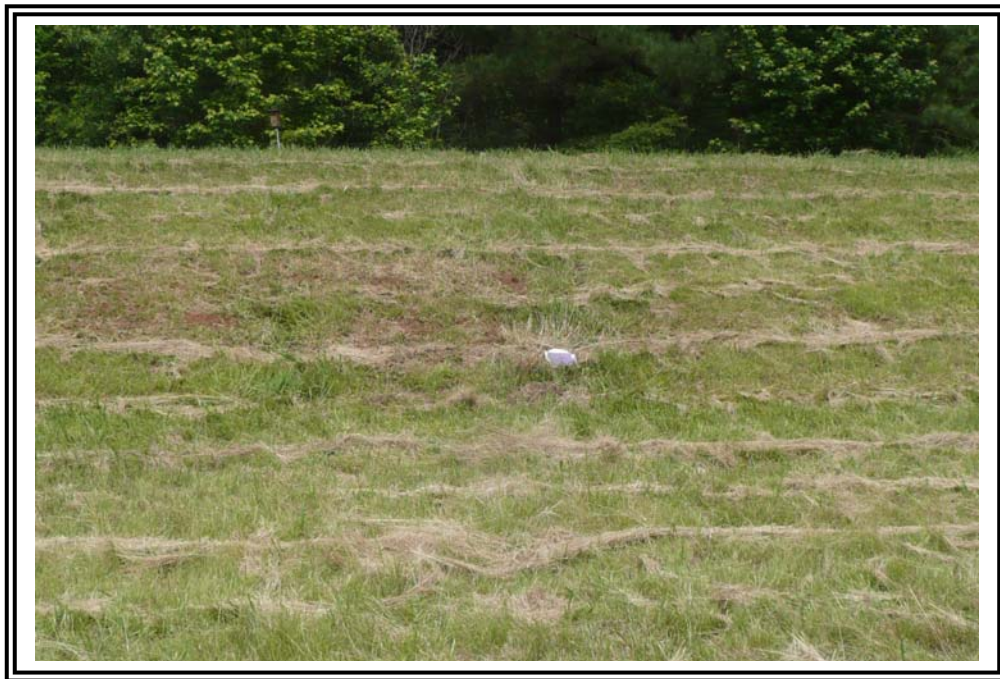
74

More erosion or settlement locations on downstream slope of Diverter Dike
as noted by clipboard and dark green grass to left of clipboard.
